PRIORITY MAINTENANCE NOTIFICATION

GUILFORD 400609

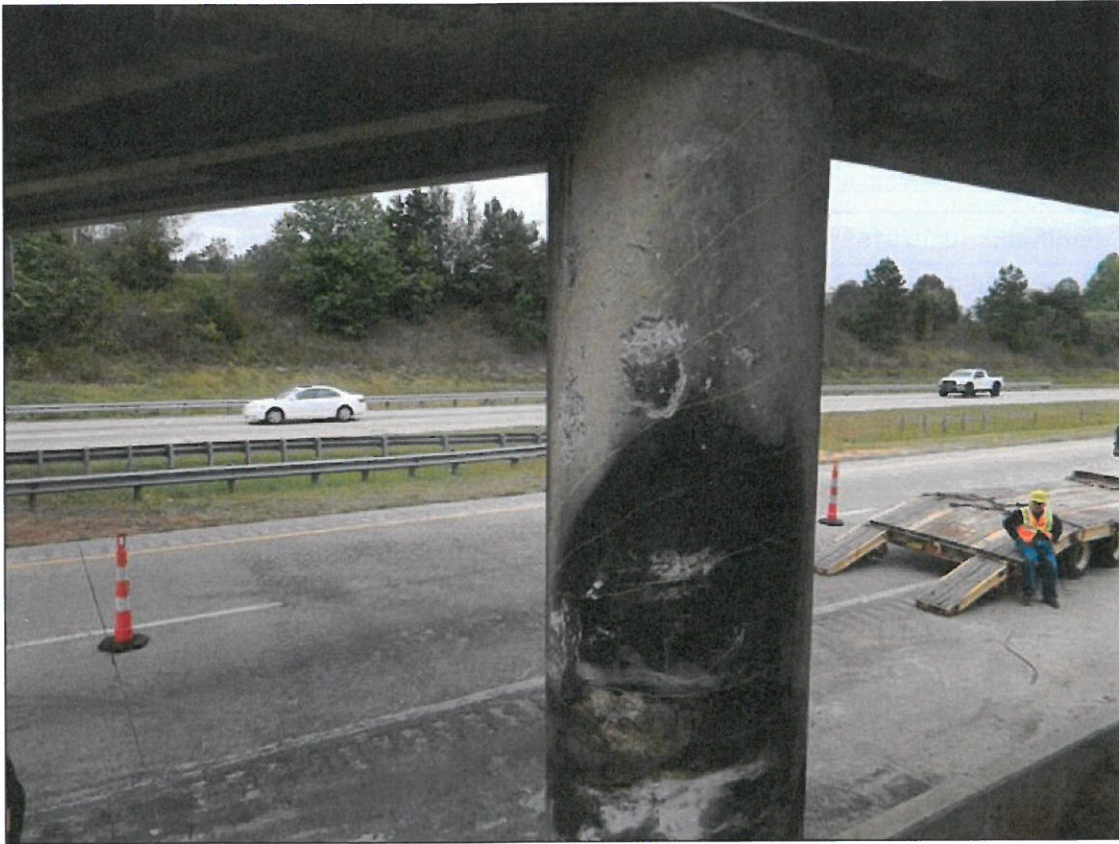
Description: PRIORITY MAINT. COLUMN 1 @ PIER 1 IS SPALLING AND DELAMINATED IN A 3'5" WIDE X 7' HIGH X 1/2" DEEP WITH EXPOSED STEEL ON LEFT SIDE.

PRIORITY MAINT. COLUMN 1 @ PIER 1 IS SPALLING AND DELAMINATED IN A 3'5" WIDE X 7' HIGH X 1/2" DEEP WITH EXPOSED STEEL ON LEFT SIDE.

Comment: Repair area to be sawcut around perimeter and chipped; both to min. depth of 1/2". In repair area, remove all unsound concrete and any concrete to 1" behind exposed rebar. Remove rust from rebar/ splice new rebar as needed. If not shotcrete or formed, use repair mat'l for vertical/overhead applications. Apply bonding agent, if required by repair mat'l. Place repair mat'l to original shape or form to add cover as necessary. Repair mat'l should have aggregate no larger than 3/8".

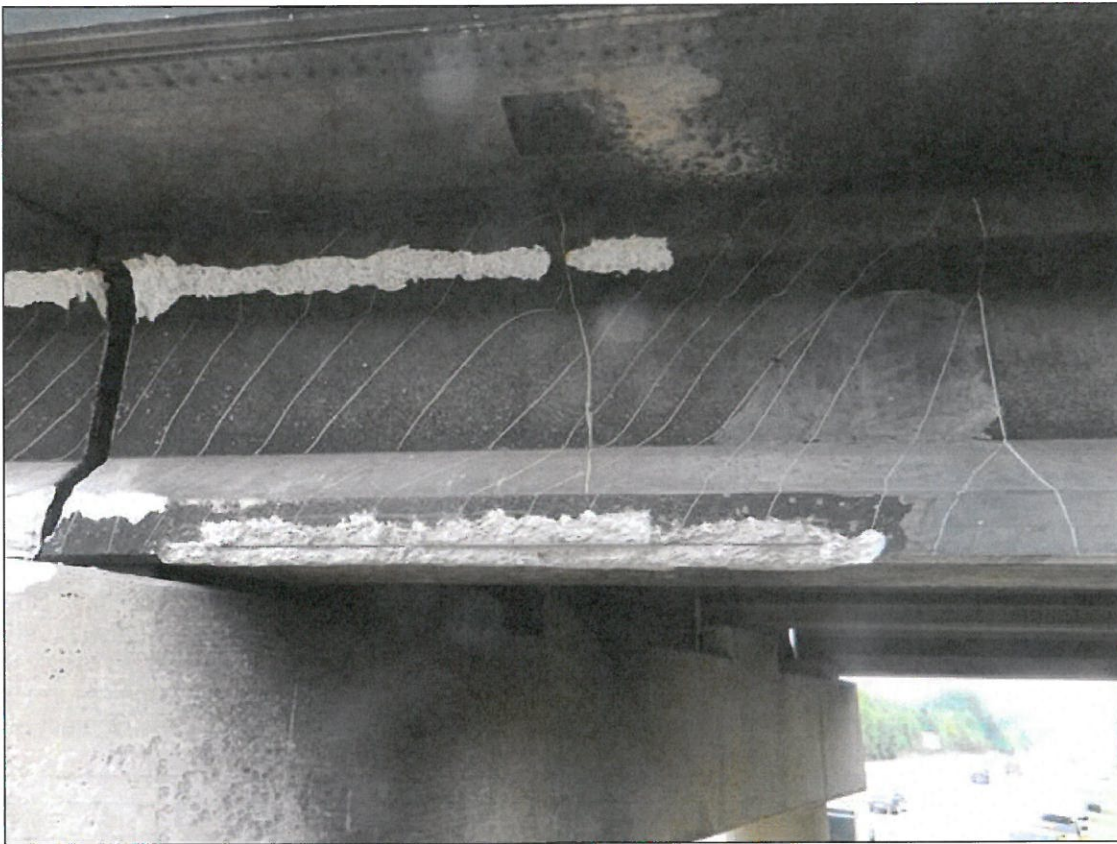
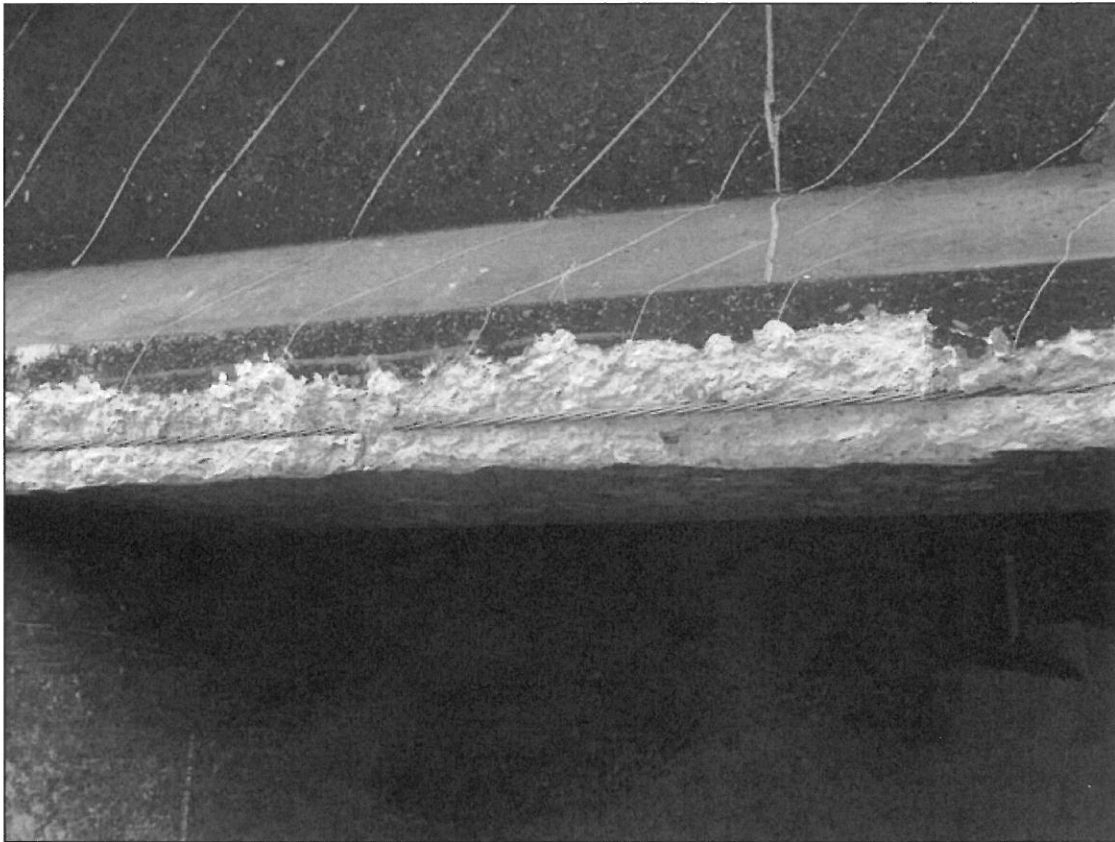
Description: PRIORITY MAINT. GIRDER 1, SPAN 1 IS DELAMINATED ON LEFT SIDE FROM END OF GIRDER OVER PIER 1 BACK 9FT LONG X ENTIRE HEIGHT. AREA WAS CHIPPED OUT ON LEFT SIDE ALONG BOTTOM EDGE IN A 6'7" LONG X 5" HIGH X 7" WIDE AREA EXPOSING 1 STRAND. EXPOSED STRAND IS DISCOLORED FROM HEAT.

.PRIORITY MAINT. GIRDER 1, SPAN 1 IS DELAMINATED ON LEFT SIDE FROM END OF GIRDER OVER PIER 1 BACK 9FT LONG X ENTIRE HEIGHT. AREA WAS CHIPPED OUT ON LE

.PRIORITY MAINT. GIRDER 1, SPAN 1 IS DELAMINATED ON LEFT SIDE FROM END OF GIRDER OVER PIER 1
BACK 9FT LONG X ENTIRE HEIGHT. AREA WAS CHIPPED OUT ON LE

Comment: Repair area to be sawcut around perimeter and chipped; both to min. depth of 1/2". Do not damage bar/strand. Remove concrete to 1/2" behind exposed bar/strand. Remove rust from rebar/strand. If not shotcrete, use repair mat'l for vertical/overhead applications. Apply bonding agent, if required by repair mat'l. Form and place repair mat'l to original shape or form to add cover as necessary. Repair mat'l should have aggregate no larger than 3/8". Contact SMU for assistance.

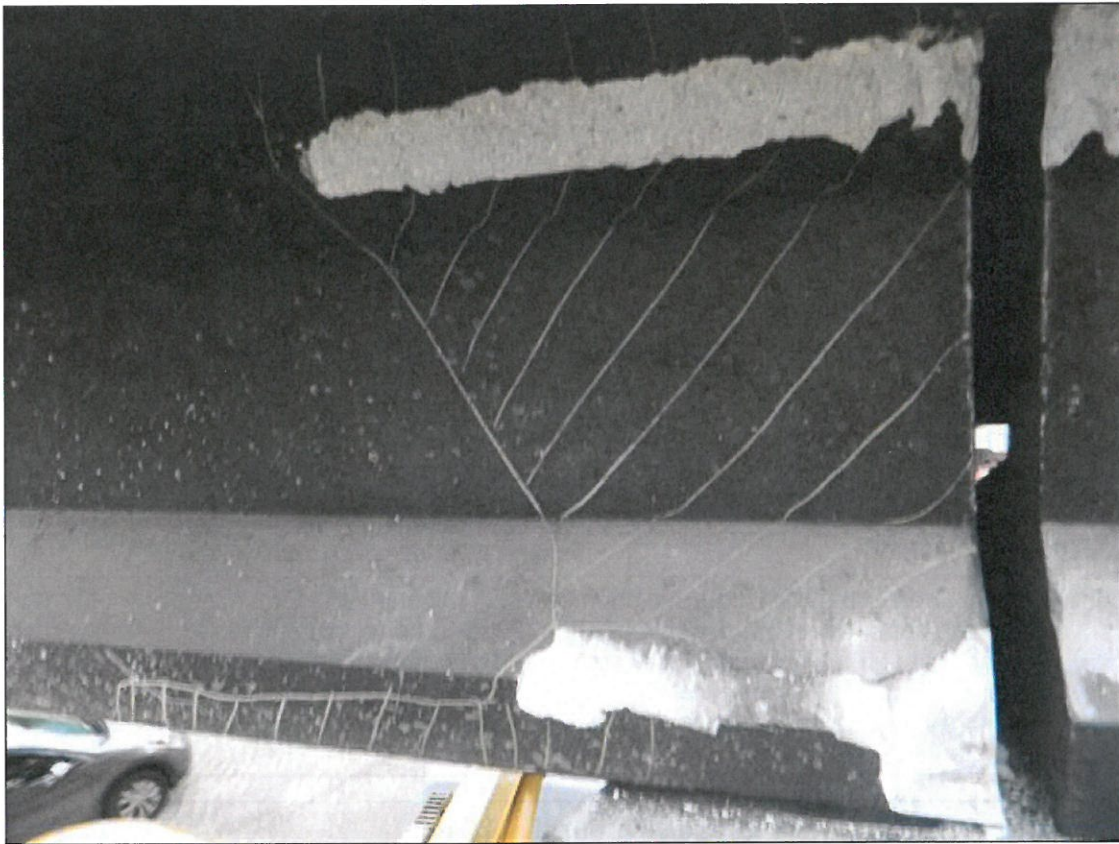
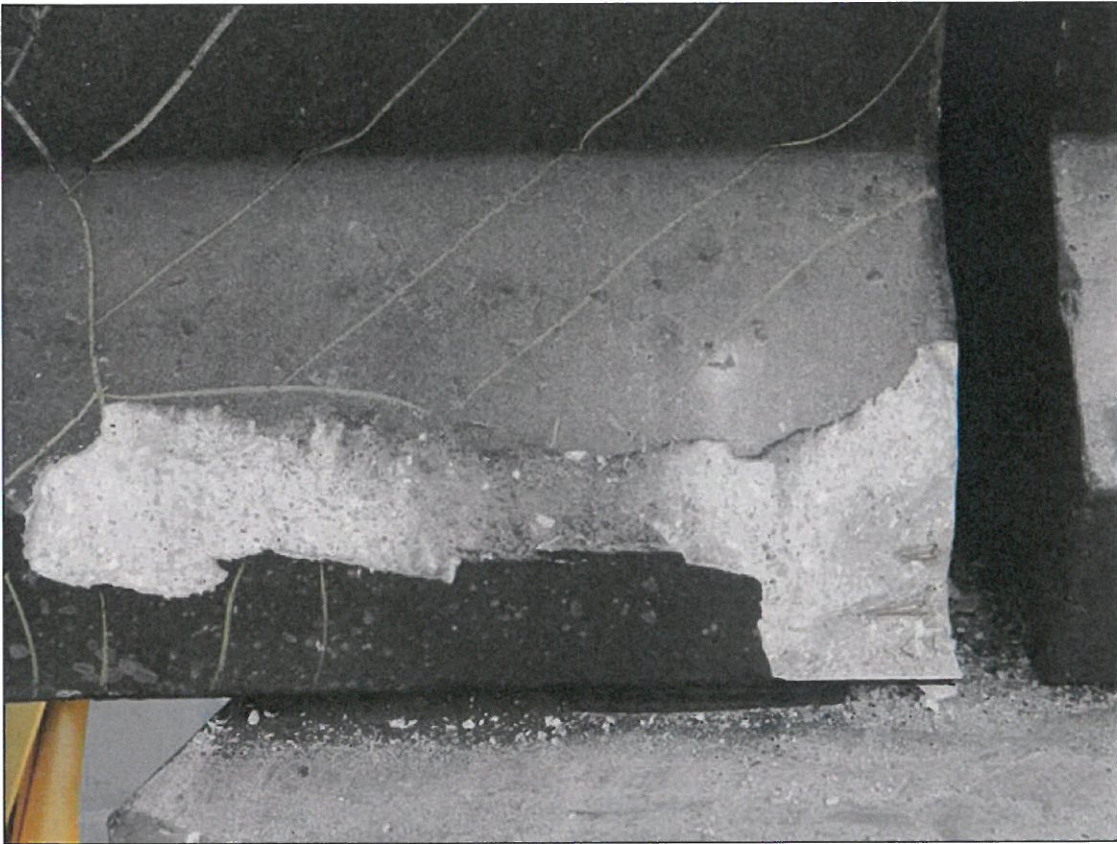
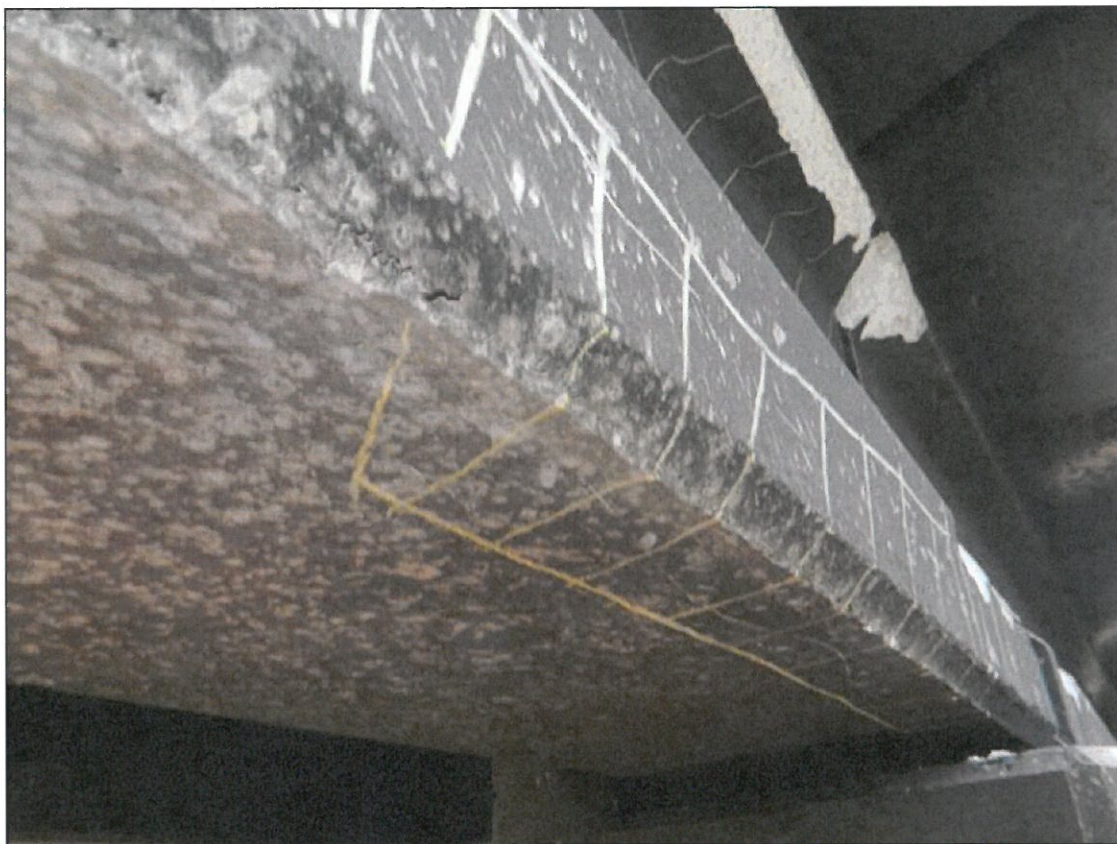
Description: PRIORITY MAINT. GIRDER 1, SPAN 2 IS DELAMINATED ON LEFT SIDE FROM END OF GIRDER OVER PIER 1 BACK 3FT LONG X ENTIRE HEIGHT. AREA WAS CHIPPED OUT ON LEFT SIDE AT END ALONG BOTTOM EDGE IN A 6" LONG X 9 1/2" HIGH X 2 3/4" DEEP AREA EXPOSING 2 STRANDS. ALSO DELAMINATED ALONG BOTTOM FROM END OUT 4' 9" LONG X 4 1/2" WIDE MEASURED FROM LEFT EDGE. ALL DELAMINATION HAS H/L MAP CRACKING PRESENT. AREAS WERE CHIPPED OUT UP TO 3" DEEP.

PRIORITY MAINT. GIRDER 1, SPAN 2 IS DELAMINATED ON LEFT SIDE FROM END OF GIRDER OVER PIER 1 BACK 3FT LONG X ENTIRE HEIGHT. AREA WAS CHIPPED OUT ON LE

PRIORITY MAINT. GIRDER 1, SPAN 2 IS DELAMINATED ON LEFT SIDE FROM END OF GIRDER OVER PIER 1
BACK 3FT LONG X ENTIRE HEIGHT. AREA WAS CHIPPED OUT ON LE

Comment: Repair area to be sawcut around perimeter and chipped; both to min. depth of 1/2". Do not damage bar/strand. Remove concrete to 1/2" behind exposed bar/strand. Remove rust from rebar/strand. If not shotcrete, use repair mat'l for vertical/overhead applications. Apply bonding agent, if required by repair mat'l. Form and place repair mat'l to original shape or form to add cover as necessary. Repair mat'l should have aggregate no larger than 3/8". Contact SMU for assistance.

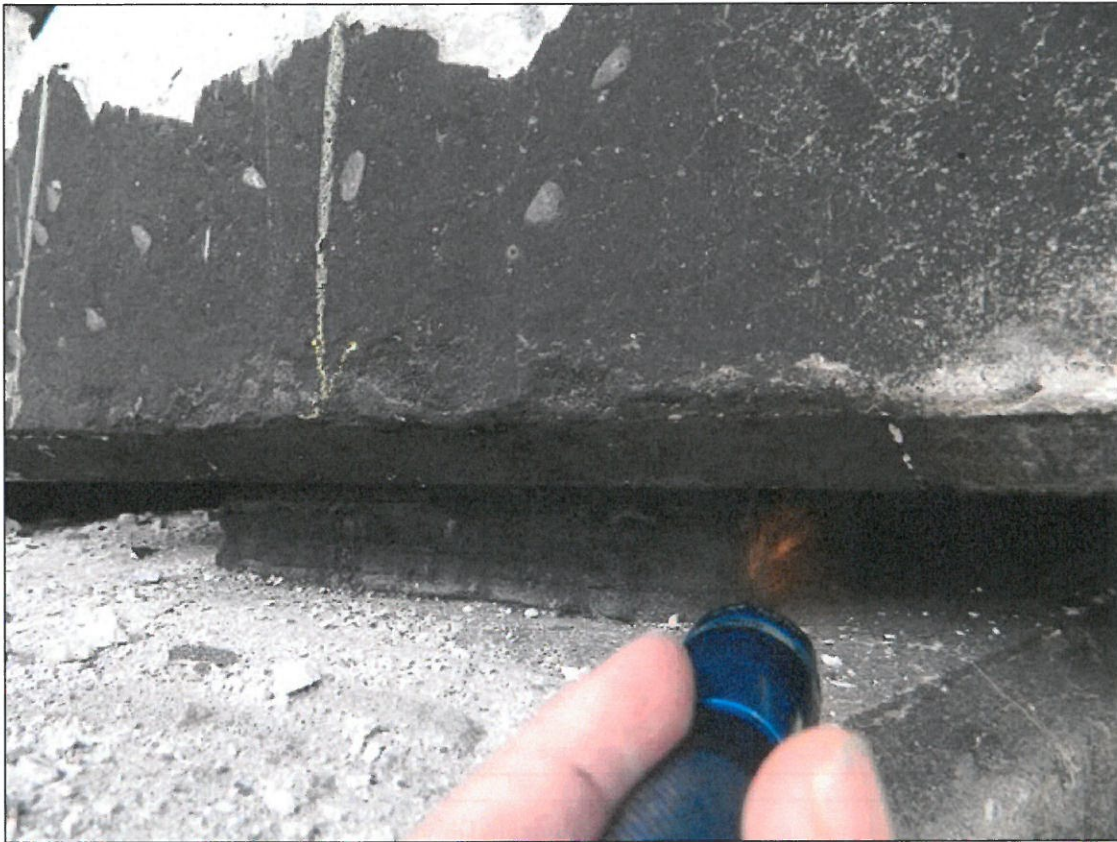
Description: PRIORITY MAINT. GIRDER 1, SPAN 1 ELASTOMERIC BEARING AT PIER 1 HAS HEAT DAMAGE. 1/4" OF CHARRED MATERIAL WAS REMOVED FROM ALL SIDES DURING INSPECTION DUE TO FIRE.

PRIORITY MAINT. GIRDER 1, SPAN 1 ELASTOMERIC BEARING AT PIER 1 HAS HEAT DAMAGE. 1/4" OF CHARRED MATERIAL WAS REMOVED FROM ALL SIDES DURING INSPECTION

Comment: Repalce bearing pad.

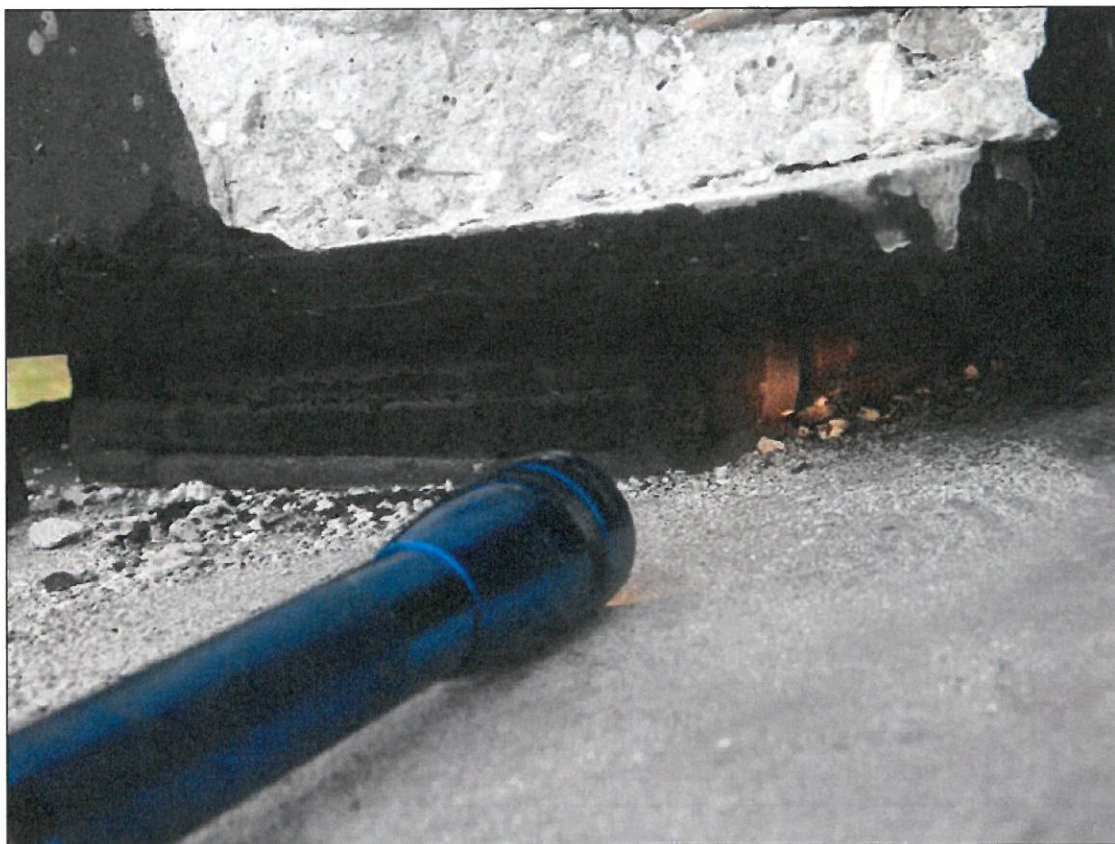
Date Submitted: 10/5/2015	Submitted By: MATTHEW WALKER	Asst. by: JOHN HAYES
Description: PRIORITY MAINT. GIRDER 1, SPAN 2 ELASTOMERIC BEARING AT PIER 1 HAS HEAT DAMAGE. 1/4" OF CHARRED MATERIAL WAS REMOVED FROM SOUTH END OF BEARING DURING INSPECTION DUE TO FIRE.

PRIORITY MAINT. GIRDER 1, SPAN 2 ELASTOMERIC BEARING AT PIER 1 HAS HEAT DAMAGE. 1/4" OF CHARRED MATERIAL WAS REMOVED FROM SOUTH END OF BEARING DURING

Assigned By: TMSHERRILL	Assigned Date: 10/8/2015
Comment: Replace bearing.
